ANNUAL REPORT FOR 2005

**Unnamed Tributary to Briery Run Mitigation Site
(Crescent Road Site)
Lenoir County
WBS Element 34501.4.1
TIP No. R-2719 WM**

Prepared By:
Natural Environment Unit & Roadside Environmental Unit
North Carolina Department of Transportation
December 2005

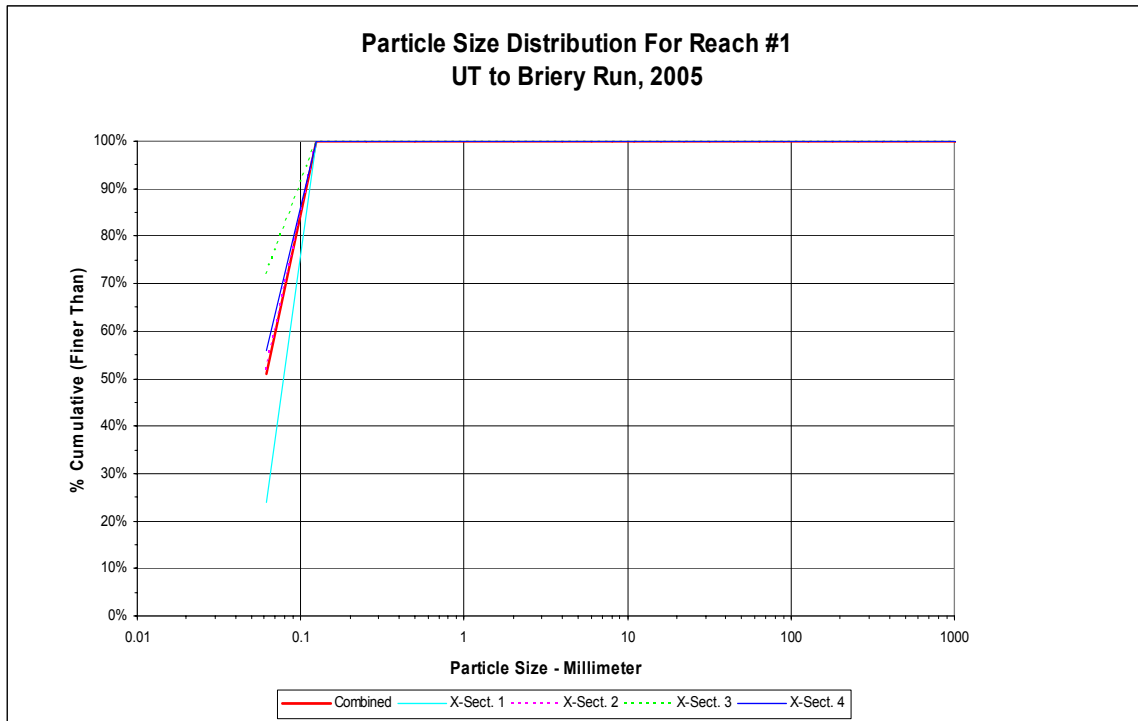
Pebble counts were taken at each cross section as a means to determine the extent of change in bed material during the monitoring period. Pebble counts taken at riffle sections were utilized to classify the stream. Existing data indicated the unnamed tributary was a sand-bed stream. The pebble counts taken during the Year 2005 monitoring period noted that the D_{50} (50 percent of the sampled population is equal to or finer than the representative particle diameter) for the riffle sections of the unnamed tributary was approximately 0.1 mm, which remains indicative of a sand-bed stream.

Charts depicting the particle size distributions for Reach #1 and Reach #2 of the unnamed tributary for 2005 are presented below.

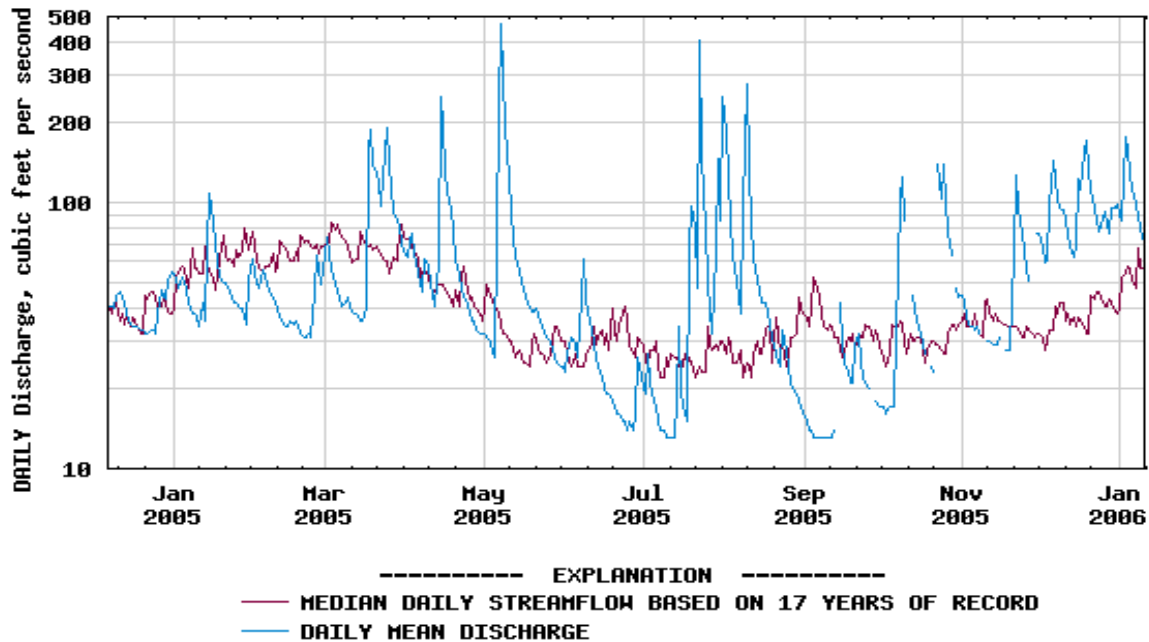
USGS 0208925200 BEAR CREEK AT MAYS STORE, NC

The Bear Creek gage was utilized for this report since it is the smaller of the two gages (57.7 square-mile drainage area as compared to the 2,692 square-mile drainage area associated with the Neuse River). The Bear Creek gage more accurately reflects hydrology and precipitation in the project area. It is situated in USGS Hydrologic Unit 03020202. Datum of the gage is 50 feet above sea level NGVD29. Based on the drainage area associated with the gage, the correlated bankfull discharge according to the NC Coastal Plain Regional Curves (USACE, 2003) is between 200 and 500 cubic feet per second (cfs). A review of peak flows was conducted for the period between October 2002 and October 2004, as well as January 2005 through January 2006. According to the graph, there were approximately eight bankfull events documented between 2002 and 2004 and two additional events during this monitoring period. This gage has met and exceeded the hydrological requirements in between 2001 and the current period. The USGS graphs depicting the peak flows occurring during 2005 is presented below.
